Inspector's Daily Report

IDR Sheet	1	of	1	Sheets	Final Record Book	Page
Contract	C-7852			Day	Tuesday	
				Date	July 5, 2011

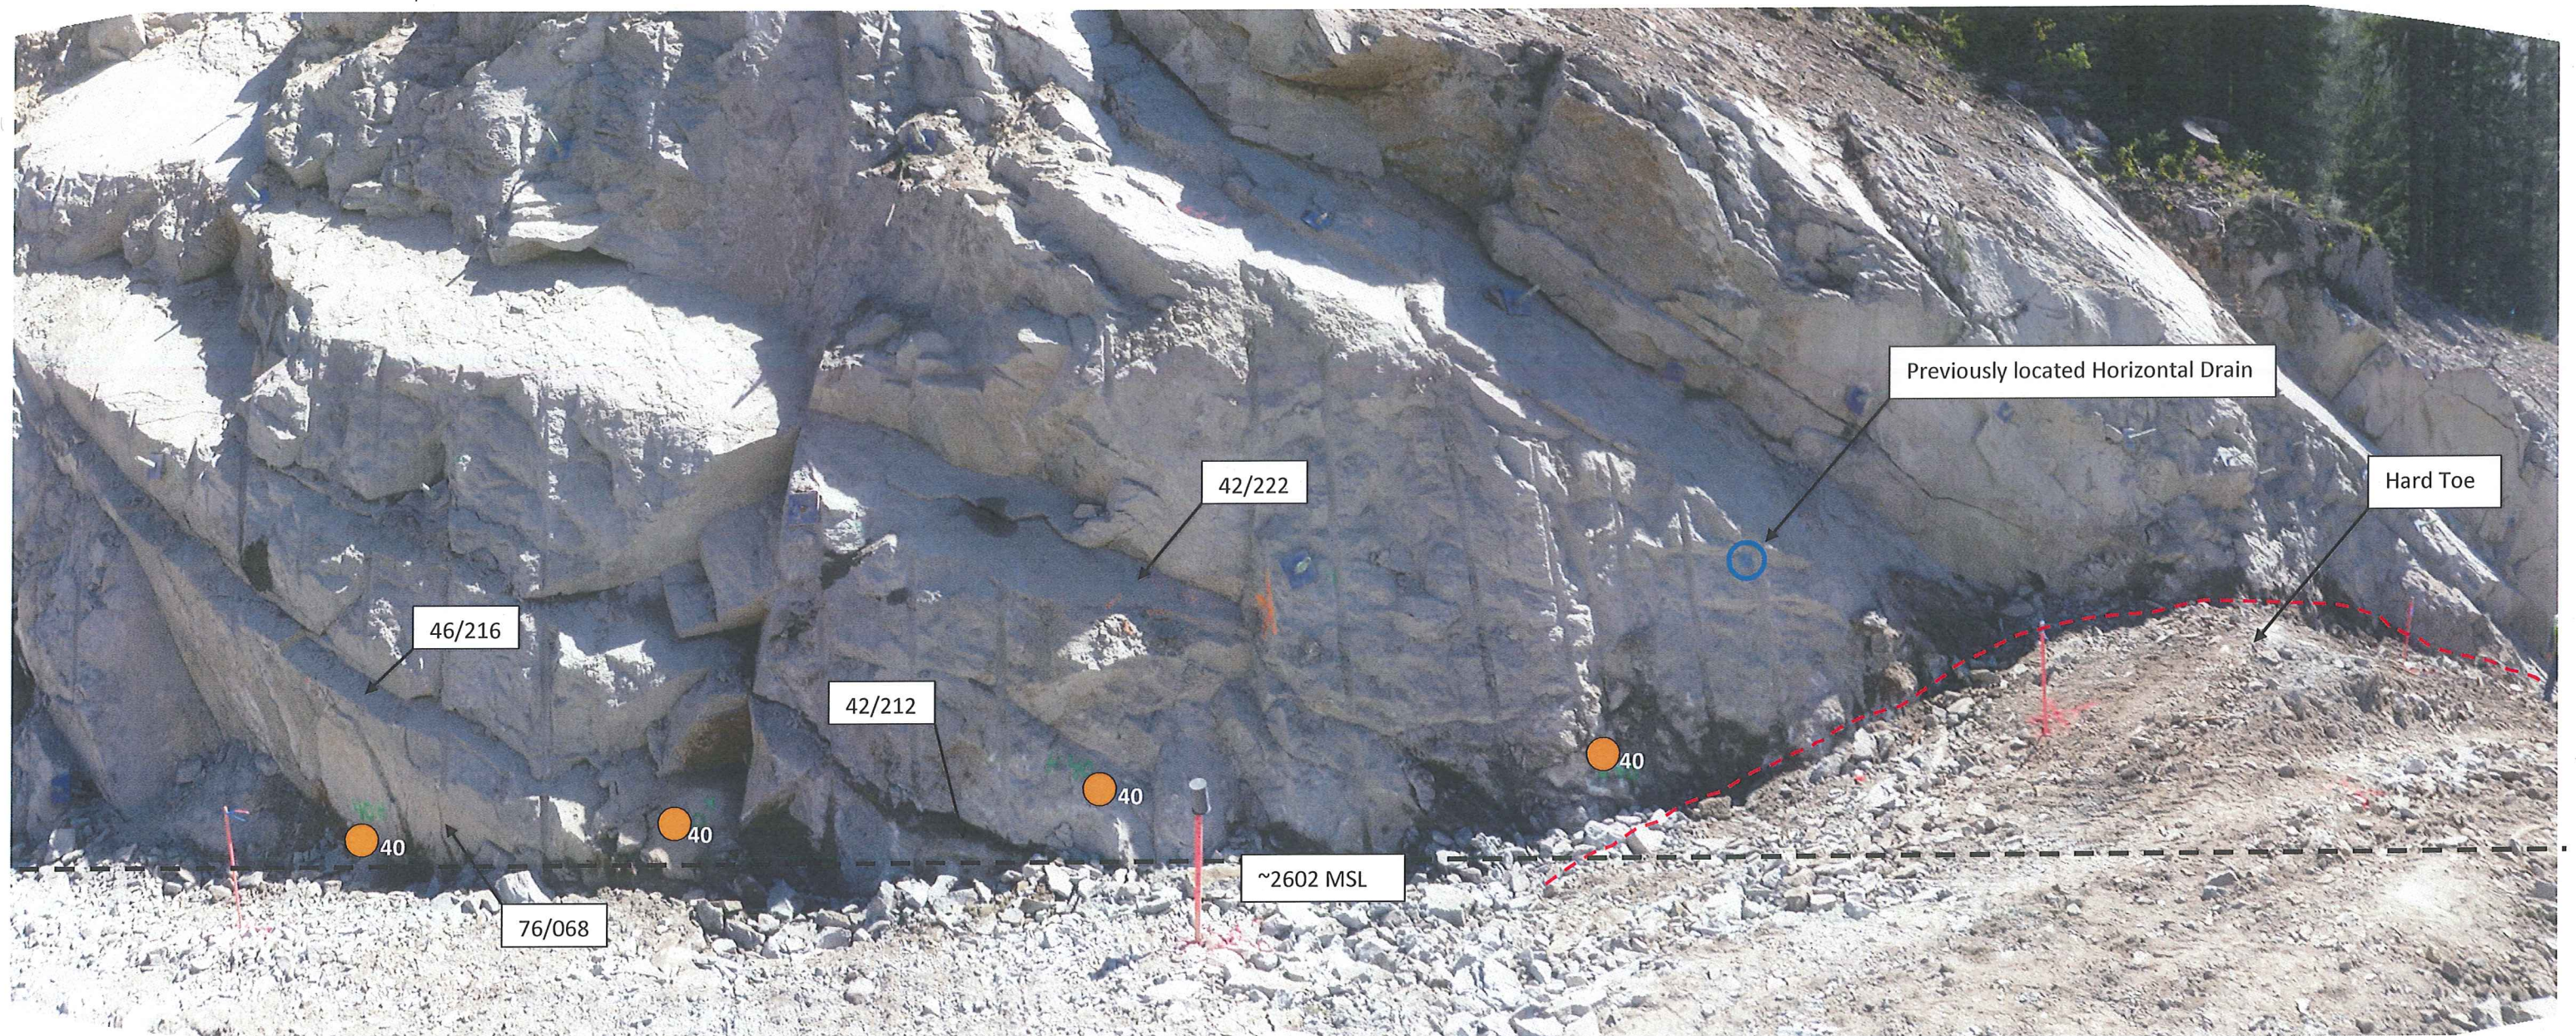
I met Brad Schut at the east side of the project around 10:30 am. Brad indicated that there were a few dowels that could be located around station 1335. Brad and I walked to the top of the slope and located four 40-foot type H rock dowels from approximate station 1334+75 to 1335+15 (Figure 1). A few more 40-foot Type H rock dowels need to be installed toward the east to connect to the existing row that was installed in 2010; however, a hard toe exists and will be removed during the upcoming blast scheduled for Thursday evening (Figure 1). Brad and I walked to the soil nail wall and it appears that the contractor has not reached bedrock at the east end of the wall and an additional row of soil nails should be installed approximately five feet below the row immediately above.

Figure 1. A photograph showing the rock dowel layout from approximate station 1334+75 to 1335+15 at approximate elevation 2602. Note the hard toe located at the right side of the photograph.
